**CAA Safety Investigation Report**  
**Loss of control on approach**  
**ZK-IMZ Guimbal Cabri G2**  
**Waikawa Beach**  
**24 August 2017**

The Civil Aviation Authority (CAA) was notified on 24 August 2017 that ZK-IMZ, a Guimbal Cabri G2 (Cabri G2) two-seat helicopter, was involved in an accident during a dual training flight. The accident occurred near Waikawa Beach in the L369 Low Flying Area.

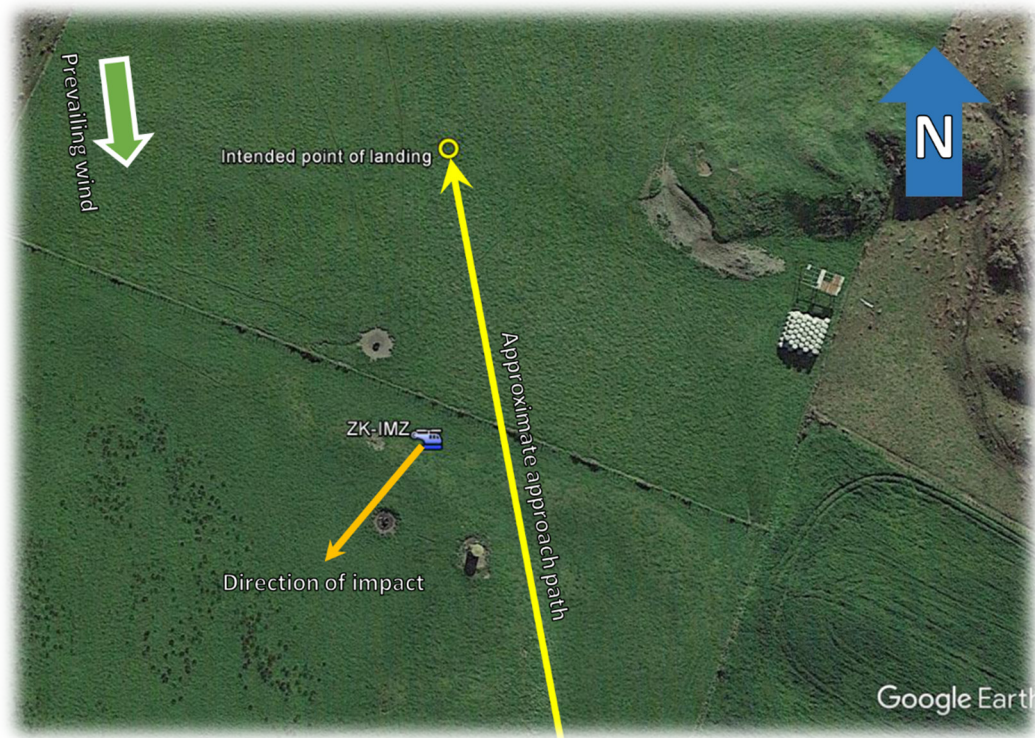
Figure 1: Accident site (Google Earth)

The helicopter was making an approach to the north, but the loss of control resulted in the aircraft changing direction and the direction of impact was to the southwest (see Figure 1). The rear portion of the landing gear dug into the ground on impact and collapsed, with the fuselage sliding to the right along the cross beams. The helicopter came to rest on its right side and received damage to the horizontal stabiliser, rotor head, and fuselage (see Figures 2 & 3). Several Fenestron blades and the three main rotor blades were destroyed in the accident. The instructor's head struck the upper-left portion of the cockpit, fracturing the fuselage above the door.

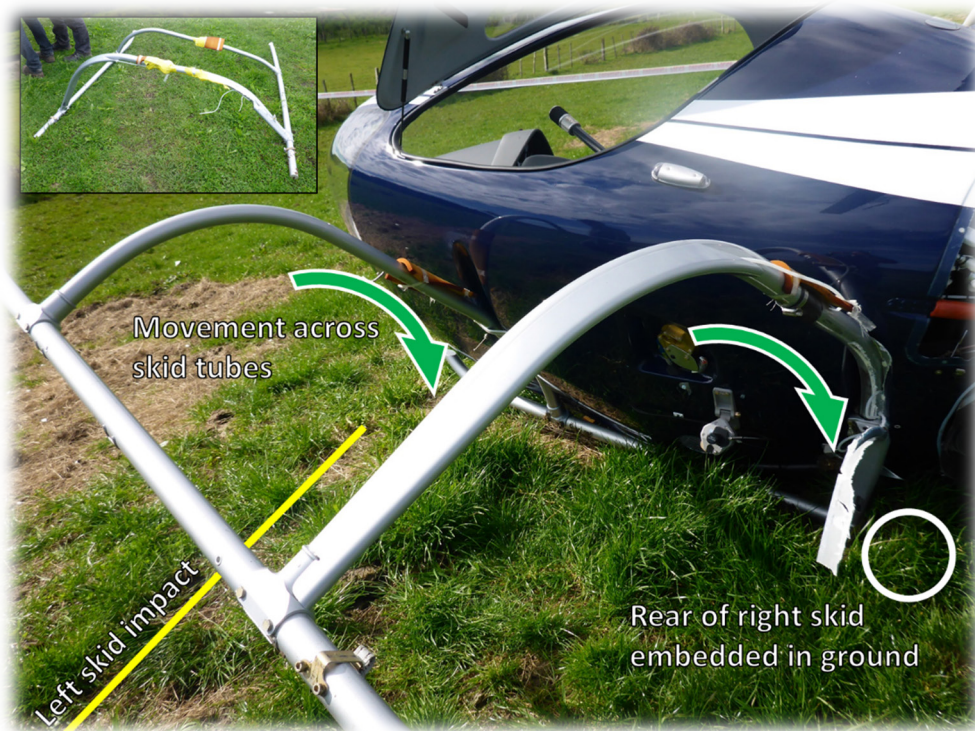
Figure 3: ZK-IMZ Landing gear (CAA photo)

The rate of left rotation is unknown, but markings on the ground indicate that there was a single impact and that the helicopter struck and rolled in place, with the rear portion of the landing gear embedded in the ground. The linear and angular momentum was absorbed by the landing gear, spreading the skids, with additional energy absorbed by the fuselage sliding across the skid tubes.

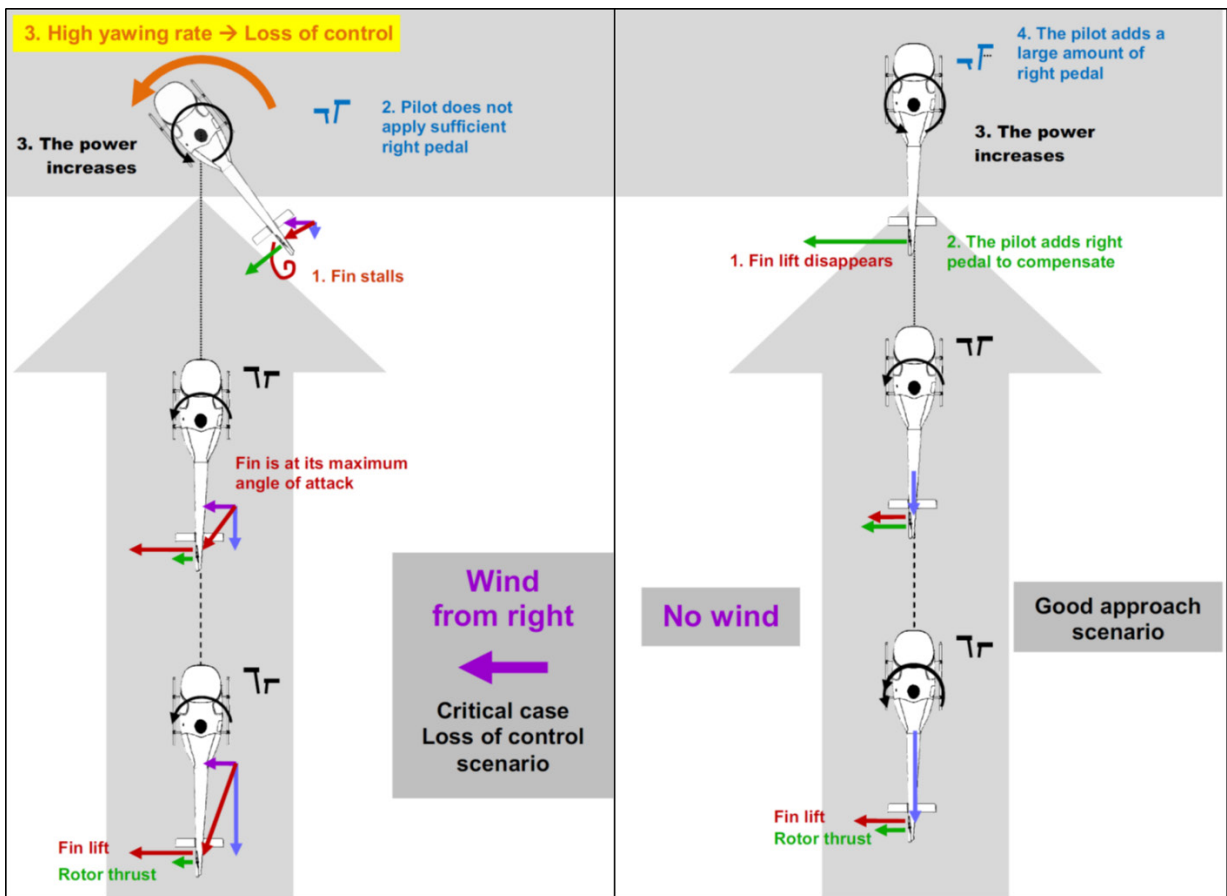
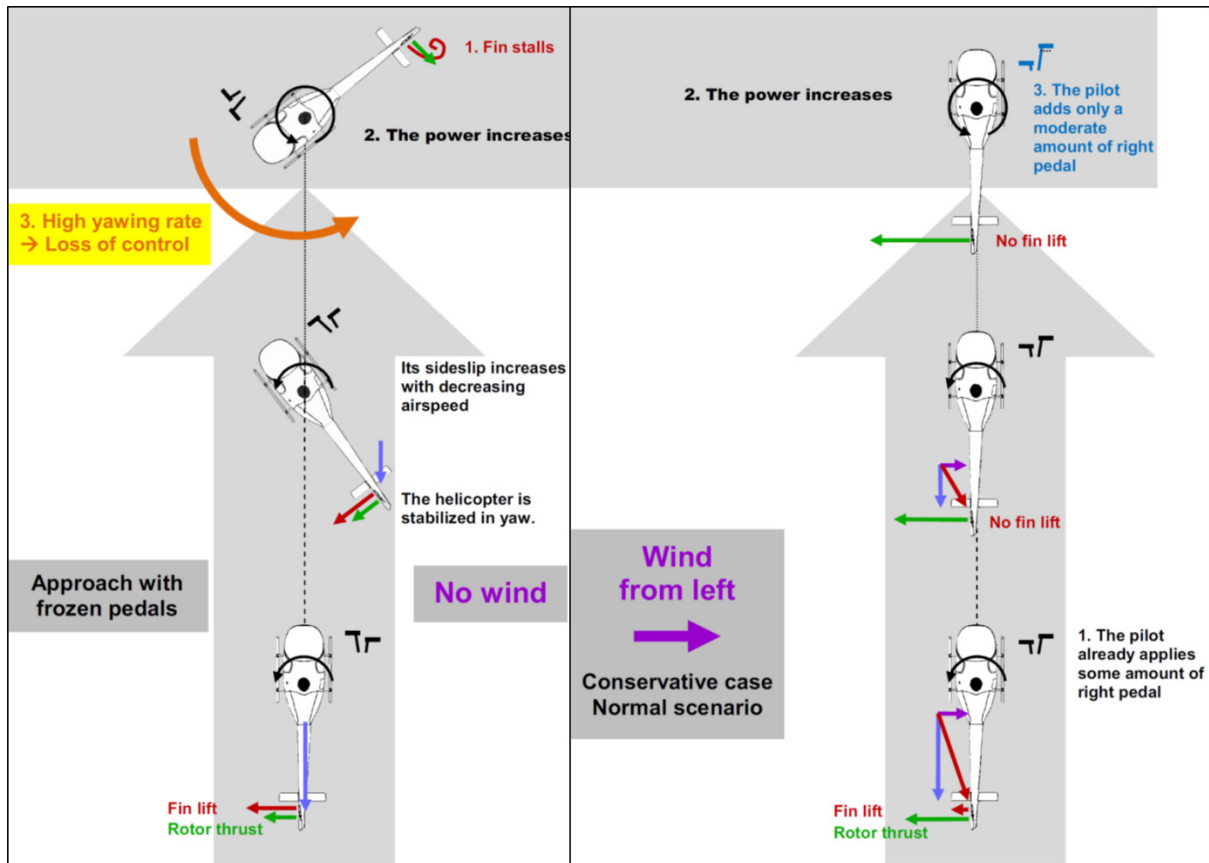
The loss of tail fin lift and increase in collective pitch require the pilot to apply a 'quick and large right pedal input' to prevent the left yaw rate from accelerating.
