**CAA Safety Investigation Report**  
**Loss of control on approach**  
**ZK-IMZ Guimbal Cabri G2**  
**Waikawa Beach**  
**24 August 2017**

The Civil Aviation Authority (CAA) was notified on 24 August 2017 that ZK-IMZ, a Guimbal Cabri G2 (Cabri G2) two-seat helicopter, was involved in an accident during a dual training flight. The accident occurred near Waikawa Beach in the L369 Low Flying Area.

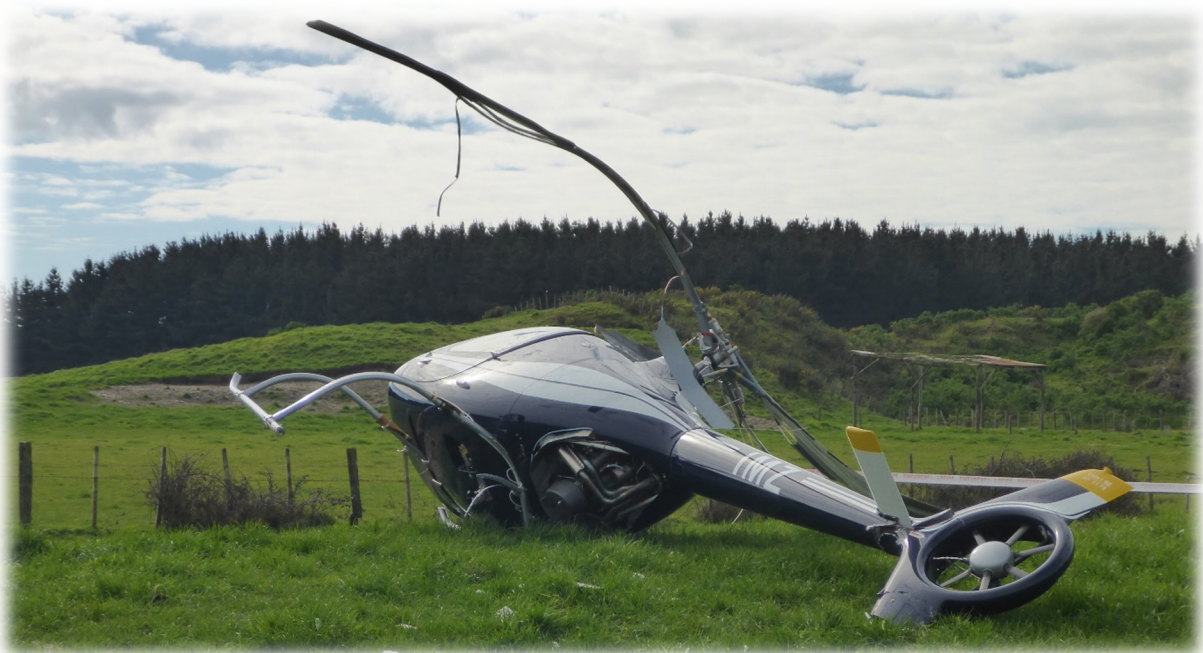
*ZK-IMZ (CAA Photo)*

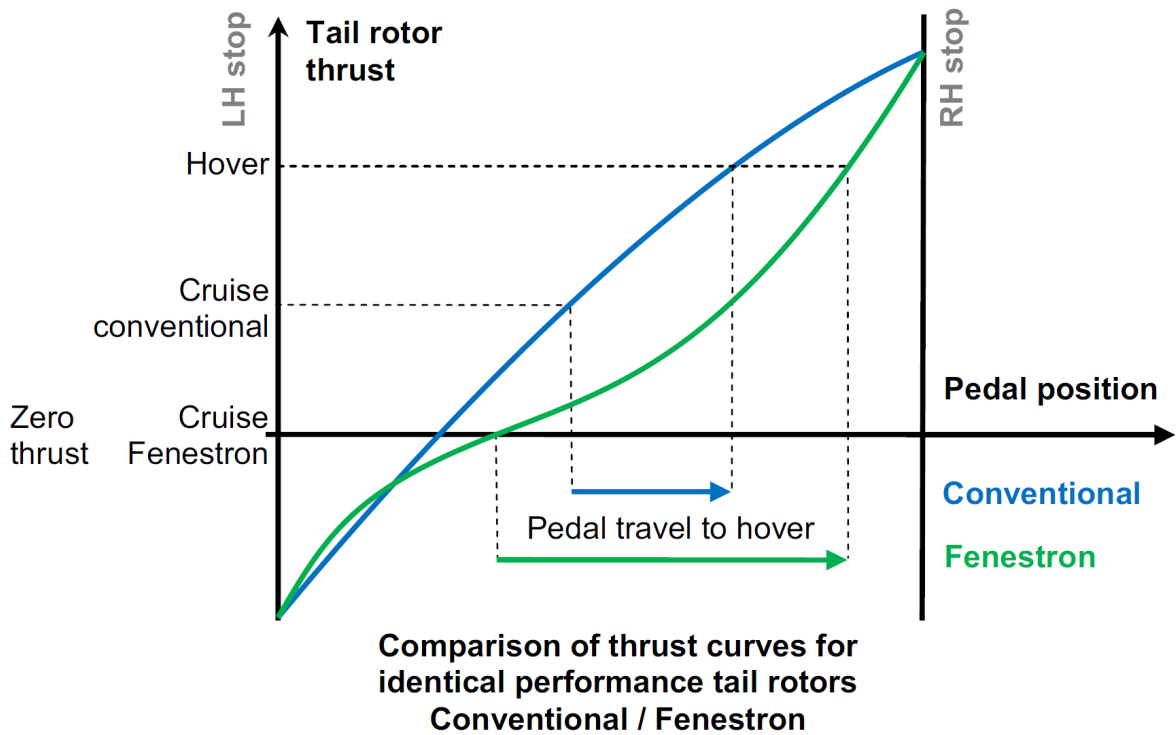
Figure 3: Comparison chart (Guimbal SL 12-001 A)

Guimbal Helicopters released Service Letter 12-001 A, *Yaw control in approach*, which describes the characteristics and performance of Fenestron anti-torque systems and conditions that may lead to a rapid left yaw. These characteristics are also described in Eurocopter Service Letter 1673-67-04.

Current information shows that loss of directional control on approach results in the highest number of Cabri G2 accidents from any single cause in New Zealand (source: *ISRA report*). The manufacturer recommends that instructors focus on the Fenestron characteristics during training and that the pilot's knowledge is checked periodically (source: *Guimbal Service Letter 12-001 A*).
